Exterior Molding Repairs That Last

BY TOM O'BRIEN

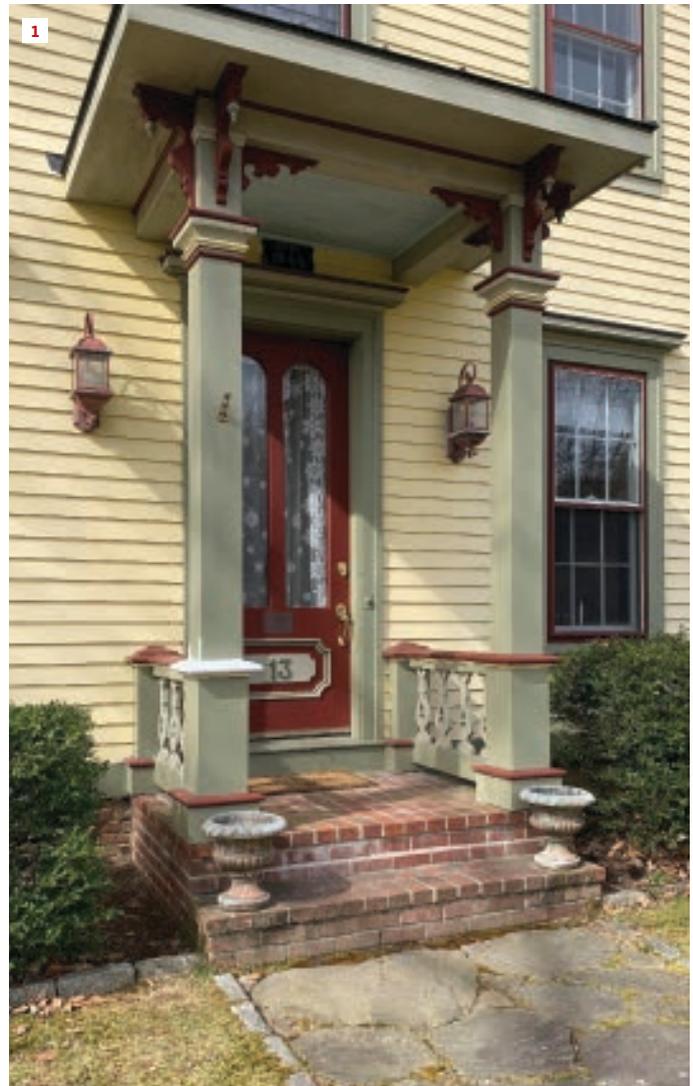
The porch trim on a historic 19th-century Italianate home wraps around the porch column, rather than simply butting up to it. Although beautiful, the design is vulnerable to moisture intrusion, which inevitably led to rot. This prompted the author to use epoxy as part of a long-term solution.

As a case in point, I was recently asked to repair a handrail on the front porch of a 19th century Italianate home in our town's central historic district (1). A unique feature of this rail was how it wrapped around the porch column, rather than simply butting up to it. Although the design was beautiful, the manner in which it was assembled had left it vulnerable to moisture intrusion; the joint where the rail sections attached to the column was obviously problematic, but it wasn't until I excavated the damage that I discovered that the bullnose edges were separate pieces, nailed and glued on. With all of those vertical joints solely dependent on caulk or glue to shed water, it's no surprise that rot eventually found a foothold (2).

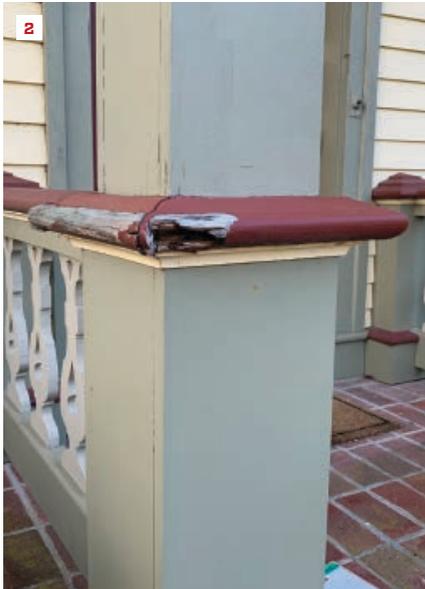
New England's volatile climate took its toll on this porch trim (2). A few severely damaged pieces had to be replaced (3). But those with minor deterioration, such as this column (4), which would have been prohibitively expensive to replace, could be stabilized with borate-based wood preservatives and repaired with epoxy.

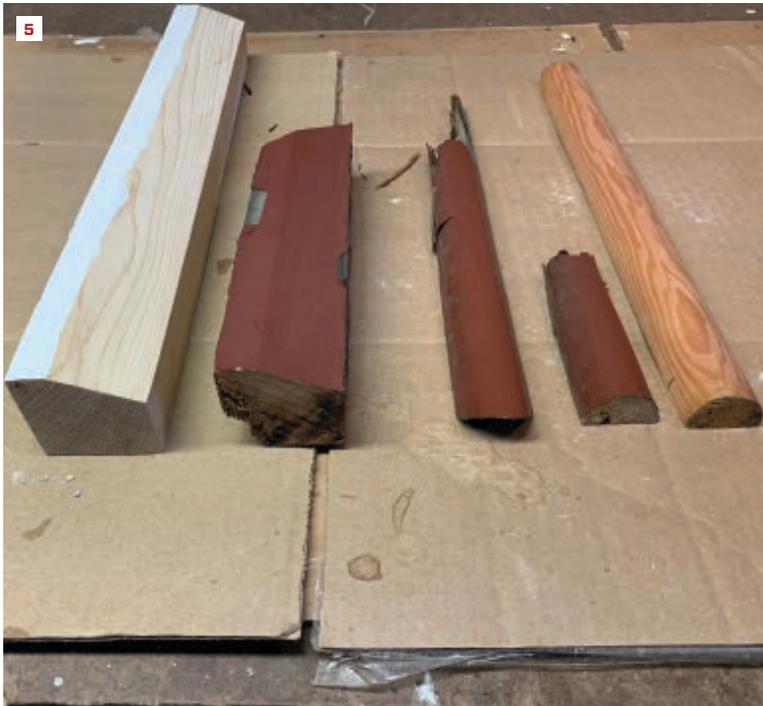
The author cut replacement moldings to size on a table saw, then primed them on their reverse sides (5). As soon as the primer was dry, he immersed the end grain in a borate solution to prevent rot formation (6).

available from a supplier, I've always been able to get there by some combination of portable planer, table saw, router bits, and profile sander. For this project, it turned out that the bullnose was exactly the same shape as a 1⁵/₁₆-inch closet pole, so all I needed was a table saw (5).

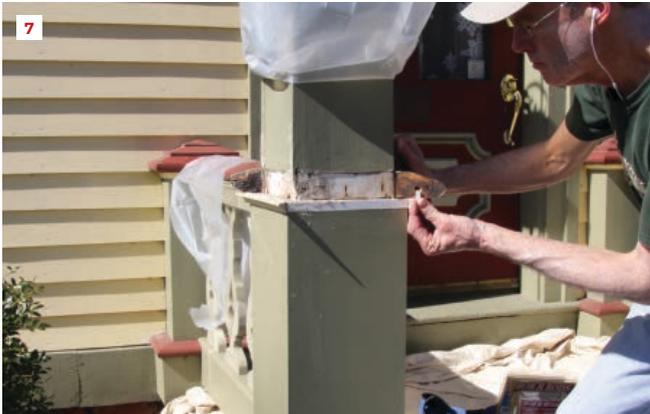
Before the miters are assembled, the author drills a hole and inserts a Bor8Rod that will provide an extra measure of insurance against rot (7).

Back on the jobsite, the old handrail pieces that we decided to save were given a double shot of borates. First, I sprayed the liquid solution on all of their porous (unpainted) surfaces. Then I drilled a ²³/₆₄-inch hole through the mitered ends and the edges that would be covered by the replacement bullnose, and I inserted a 1/3-inch-by-1-inch Bor8Rod into each hole (7). This crystalline tube of boric acid, which is available in a variety of sizes, serves like a time-release capsule that stays dormant unless it gets wet, whereupon it dissolves and kills any rot spores that attempt to gain a foothold.

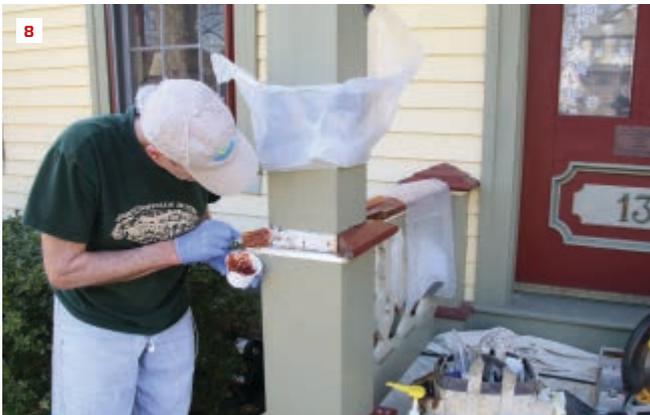
Marine epoxy adhesive ensures that miter joints that are exposed to the elements won't separate (8).

As soon as the wood was saturated with epoxy, I added West System #407 Low-Density Filler to the remaining liquid and stirred enough of it in to create a gap-filling adhesive roughly the consistency of mayonnaise. After spreading a thin layer of this concoction on one side of each joint (8), I assembled the pieces and fastened them with stainless steel air nails. Then I wiped the squeeze-out from each joint and covered the repair with plastic to keep the heat in overnight.

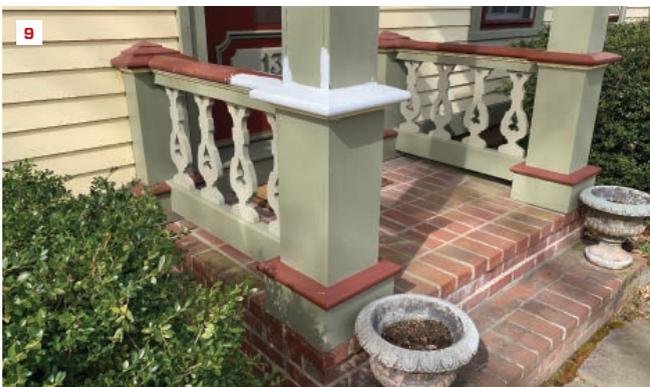
With two coats of paint and an annual inspection, this repair should last indefinitely (9).

The following day, after I sanded the rough spots, all the railing would require from then on was primer, caulk, paint, and (hopefully) an annual inspection (9).
